Kari Rayner, Kathryn Brugioni, Megan Randall, Jessica Walthew
Conservation Center, Institute of Fine Art, New York University

Smoke and Mirrors: Revealing Chanler's Whitney Studio Fireplace

The former studio of Gertrude Vanderbilt Whitney, located at the New York Studio School in lower Manhattan, contains one of the most important commissions of artist Robert Winthrop Chanler: a 20-foot high, painted plaster-and-bronze fireplace, likely completed in 1923. A study of the structure began in January 2013, initiated by the World Monuments Fund as a joint effort between the Conservation Center of the Institute of Fine Arts at New York University and Columbia University's Historic Preservation Program.

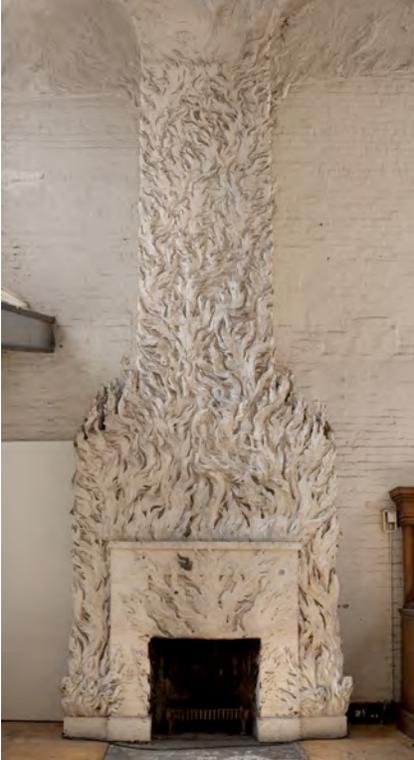
Figure 2. Robert Chanler, *Fireplace*, 2013.

Chanler created a bas-relief plaster ceiling and sculptural fireplace, which are still present today as seen in figure 2. The fireplace consists of three-dimensional flames containing hidden creatures such as birds, snakes, fish, lizards, and humans (figs. 3a-c). In addition, the studio contained a decorative screen and stained glass windows designed by Chanler: the resulting ensemble was meant to be a personal, creative sanctuary for Whitney.

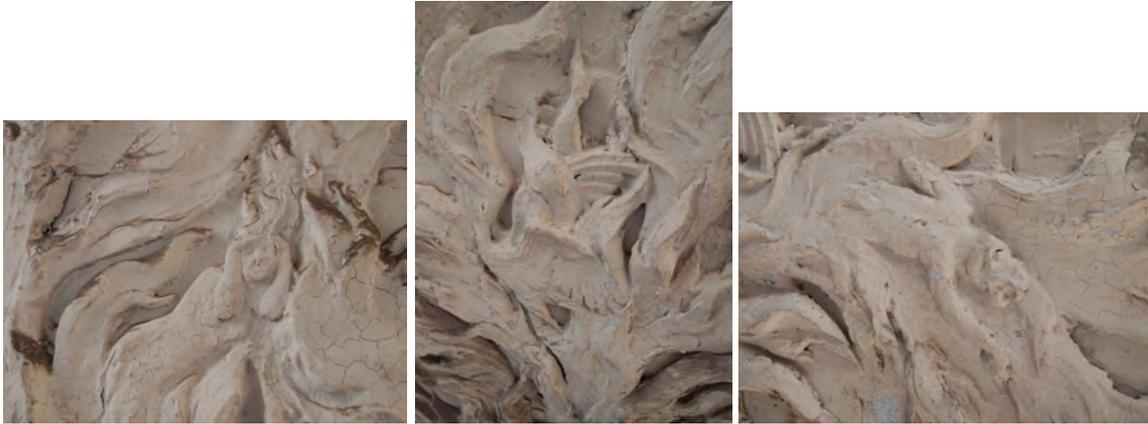
Figures 3a, 3b, 3c. Detail of Chanler Fireplace, 2013. Courtesy of Elizabeth Frasco. March 20th, 2013

In constructing the fireplace for Whitney's studio, cast bronze flames were installed at the base in two phases over an existing brick chimney structure. The metal transitions into sculpted plaster flames, which transition again at the ceiling into plaster bas-relief. Freestanding flame elements were cast in molds and are supported by wire armatures.

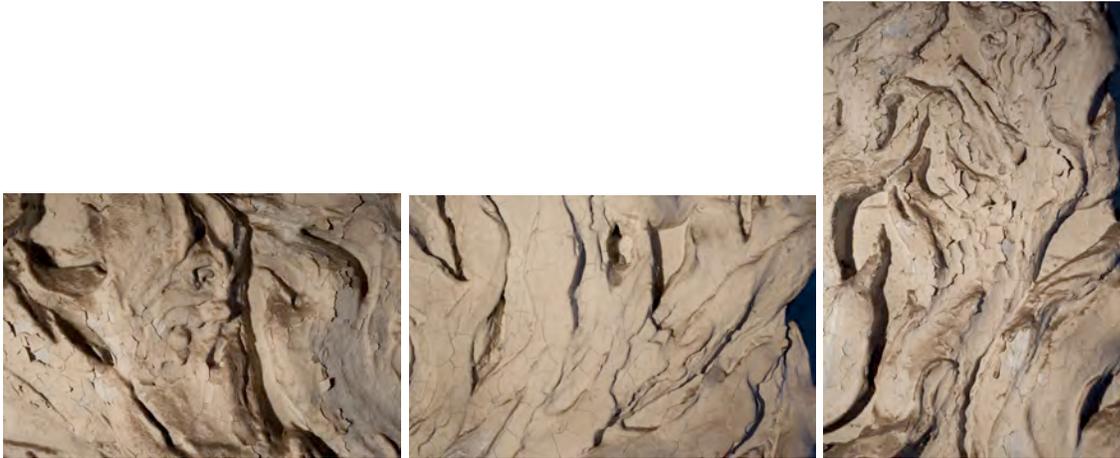
The team documented all condition issues with digital photography and created color-coded condition maps. The most severe preservation concerns relate to water infiltration through the roofing. This has caused significant aligating, flaking and delamination of the paint (figs. 4a-

c). The thick layers of overpaint obscure not only the original polychromy, but also a significant amount of three-dimensional detail.

Figures 4a, 4b, 4c. Alligatoring, delimitation, and the resulting flaking and loss was visible through much of the white overpaint. Right: Level B, E Elevation; Center: Level A, E Elevation; Left: Level B, E Elevation. 2013.

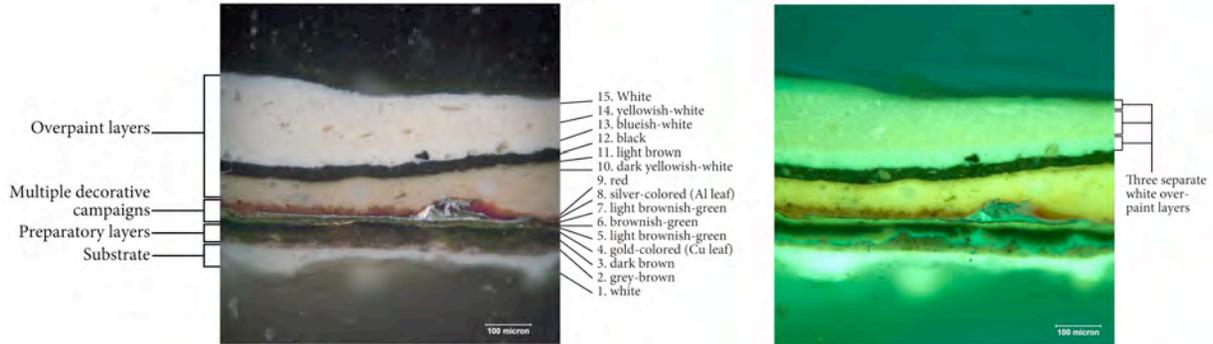
All of the samples were microscopically analyzed in cross section in both normal and ultraviolet light (fig. 5). In general, up to 25 layers of metal leaf and paint, and anywhere from two to ten decorative finishes total were found per sample.

Figure 5. Example of a typical cross section, NYSS034, showing the method used for identifying and labeling the paint layers.

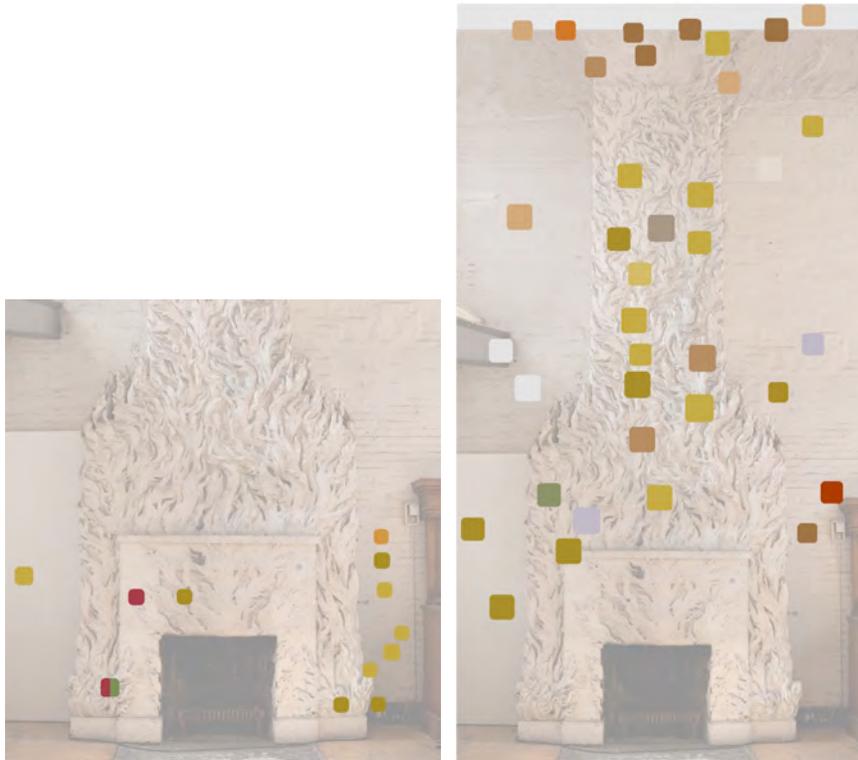
A number of methods were utilized in attempting to determine an overall pattern of finishes. Colors as observed in cross section were matched with the Munsell Color System and mapped (figs. 6a, b). The team then attempted to visually map the location and chronology of these colors.

Figure 6a (left). Metals Scheme, Finish 2. This map shows the approximate colors of the second finish campaign in complete samples taken from metallic substrate.

Figure 6b (right). Plaster Scheme, Finish 2. This map shows the approximate colors of the second finish campaign in complete samples taken from plaster substrate.

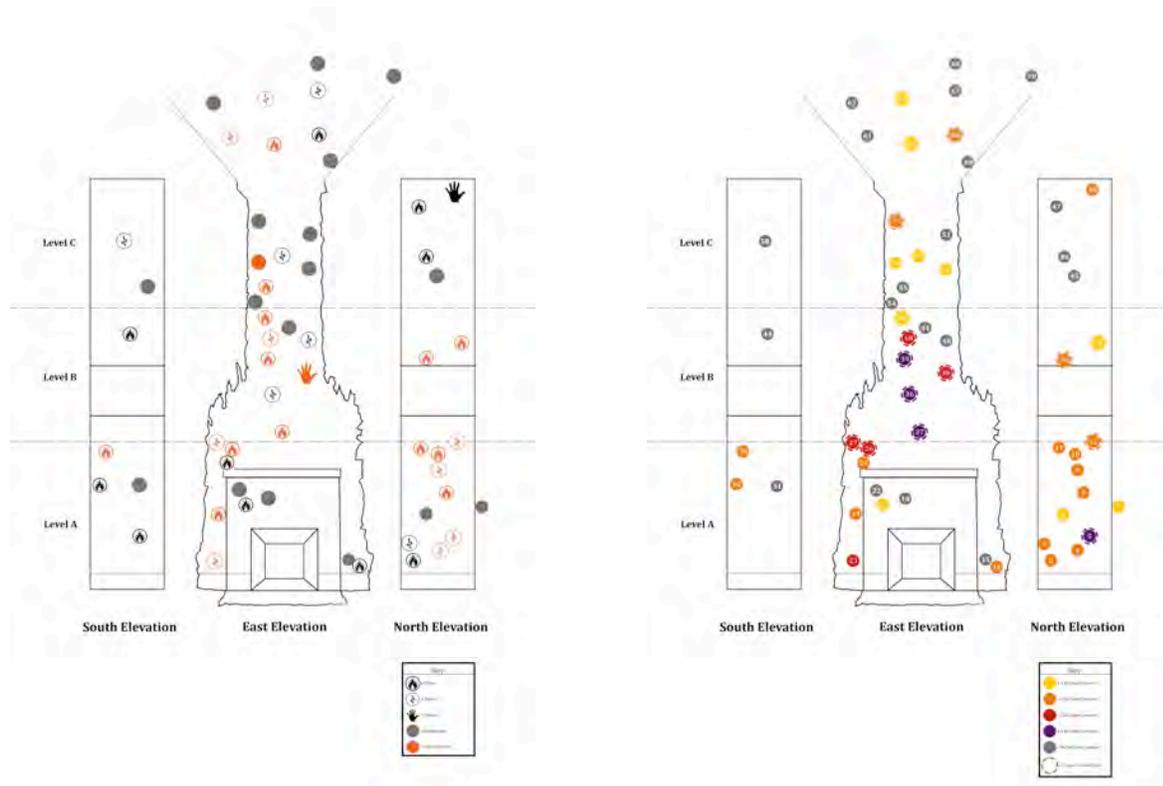
Additionally, color-coded maps were created to indicate different characteristics of the samples in an attempt to find correlations between them which could suggest the appearance of finish campaigns overall (fig. 7a, b).

Figure 7a (left). Categories of samples. This map indicates whether cross sections were taken from Flames, Animals, or Human figures.

Figure 7b (right). Foil Layers: This map indicates the presence of foil layers, their number, and type.

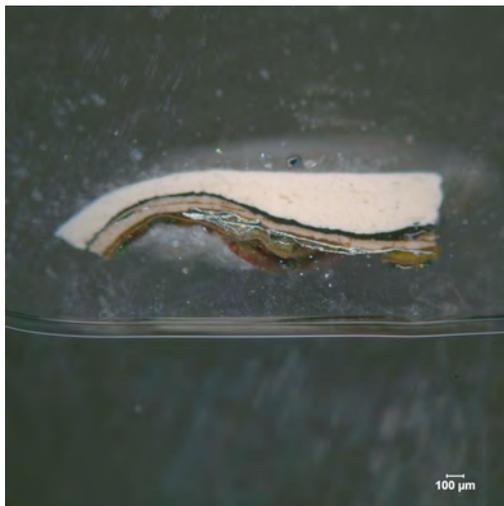
The samples also proved to be enormously complex (fig. 8). As aforementioned, the team found up to twenty-five layers per sample. Some of these layers were so thin and indistinct, they were only barely visible in ultraviolet light, and many layers also were not of consistent thickness. In addition, we encountered poor adhesion and interpenetration between layers, which convoluted our interpretation of discrete finishes.

Figure 8. Sample NYSS037: This cross section is from the center of a plaster flame element showing 6 total finishes and 5 layers of overpaint. Level B, E Elevation. Photomicrograph, 2013

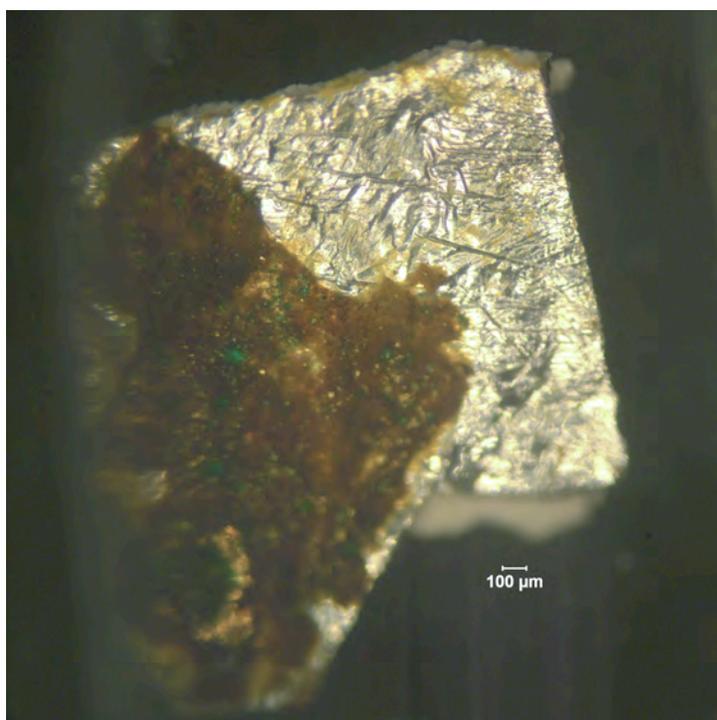
Early in the microscopic examination phase of the cross sections, supervising conservator Mary Jablonski suggested that perhaps bronzing powder was present in the samples. Lauren Drapala, who conducted the study of the ceiling, also suggested the use of bronzing powder. The team took a number of overhead photomicrographs of samples before embedding them in bioplastic in order to examine this phenomenon (fig. 9).

Figure 9. Sample NYSS025: This sample from a plaster flame near the hearth is possibly an incomplete sample. It appears that a copper or aluminum leaf is missing, from which the sample likely cleaved. The cleft face revealed flecks of green and gold, possible bronzing powders. Level A, E Elevation. Photomicrograph, 2013.

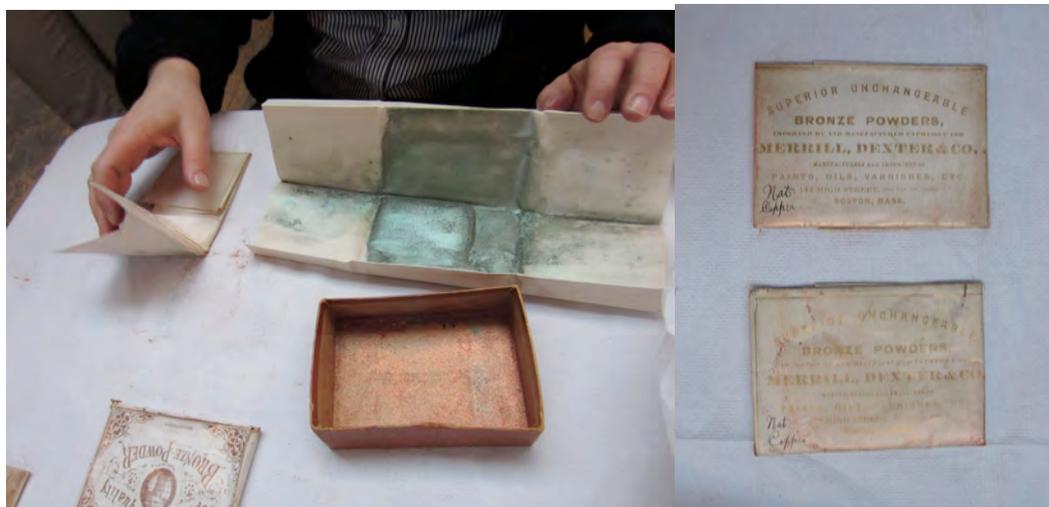
Bronzing powder is a fine metallic powder used in decorative painting techniques popular during Chanler's time. The powder could be mixed into a medium for application or could be sprinkled on a wet paint layer to provide a metallic dimension (fig. 10a, b). Bronzing powder was manufactured in a broad palette of colors, including more traditional metallic tones, as well as green, orange, blue, and purple in various shades.

Figure 10. Green- and bronze-colored historic bronzing powder samples, provided by Mary Jablonski, 2013.

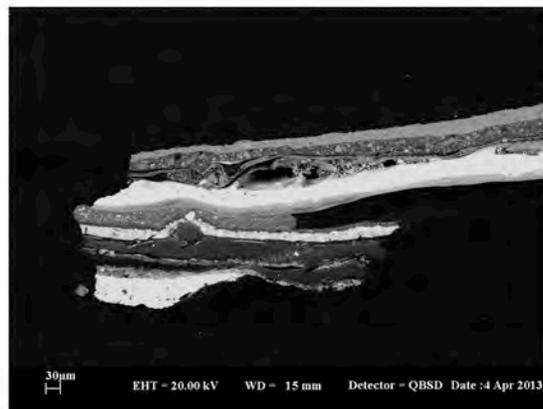
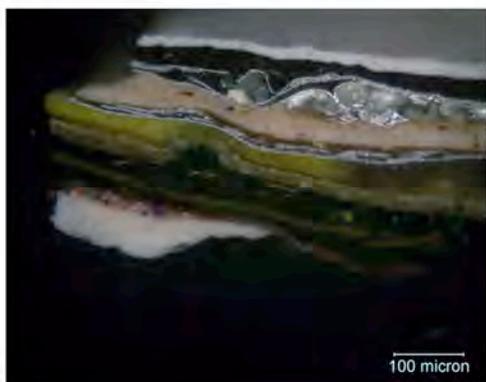
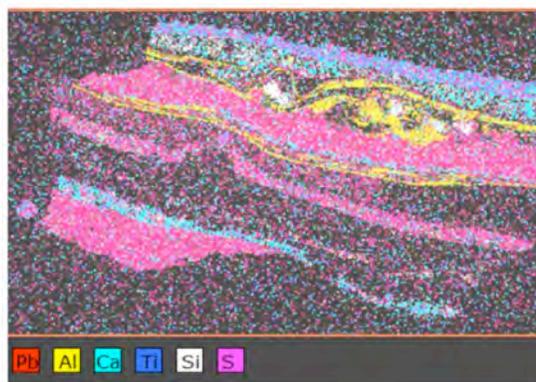
Figure 11. Scanning Electron Microscopy of sample NYSS011.

The team examined the layers in cross section which corresponded to those hypothetically containing bronzing powder using various analytical techniques. These layers usually appeared somewhat like a green glaze in cross section. In one sample, SEM-EDS showed the presence of elements (copper chlorine, oxygen and iron), which are typical of copper corrosion products, surrounding fragments of copper leaf (fig. 11). This suggested that perhaps bronzing powder was not present, but that instead the samples possibly contained layers of copper leaf that had partially deteriorated, resulting in green corrosion products. Examination with FTIR showed relatively close matches for copper stearate in one sample and cupric palmitate in the other, products which appear to relate to corrosion (fig. 12a, b).

- Layer 18 - White: Ti
- Layer 15 - Black: Mg, Ti, Zn, Al, Si, Ca, C, O
- Layer 14 - Tan: Pb, Fe, Mn
- Layer 10 - Yellow: Pb, Cr, O (chrome yellow)
- Layer 9 - Silver-colored Leaf: Al
- Layer 7 - Light Brown: Ba, Pb, O, S
- Layer 5 - Gold-colored leaf: Cu
- Layer 4 - Green: Cu, Cl, O, Fe (copper corrosion products)
- Layer 3 - Pink: Ca, S, Si, Mg, Al, O (with Ba in isolated barite particles)
- Layer 1 - White: Pb, Zn (primer layer) (note: substrate absent from this sample)

NYSS011 viewed at 430x magnification (SEM).

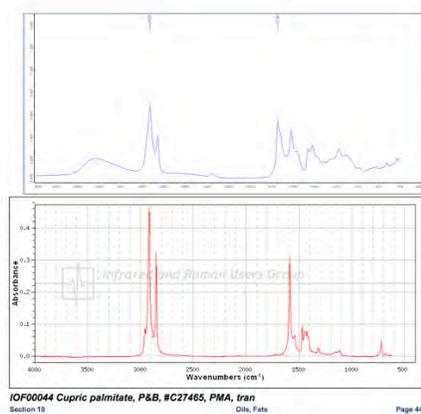
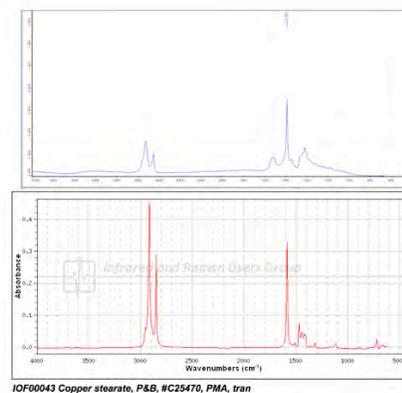
NYSS024, green Layer 13

NYSS011, green Layer 4

Figure 12a (left). FTIR Results for NYSS024, layer 13. This image compares the signal from the sample to that of cupric palmitate, a copper corrosion product.
Figure 12b (right). FTIR Results for NYSS011, layer 4. This image compares the signal from the sample to that of copper stearate, a copper corrosion product.

Unfortunately, the team could not conclusively rule whether the corrosion products were the result of the degradation of copper leaf, or whether they are a component of a bronzing powder. This was one of the most significant unanswered questions at the conclusion of this study.

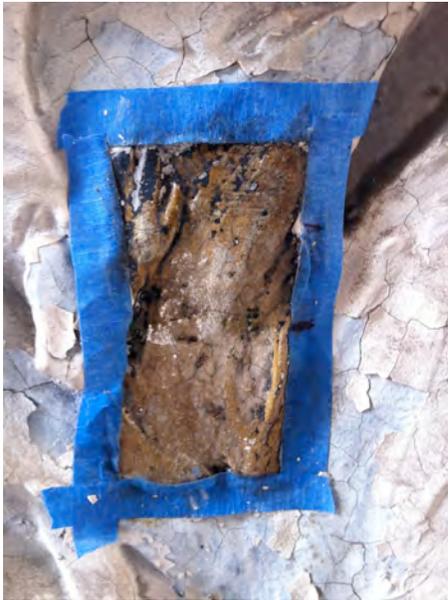
As previously discussed, reveals were performed both on previously-detached plaster fragments and on areas of the fireplace itself. Reveals represent a fundamentally different analytical approach for architectural versus fine arts conservators, since they are highly invasive and often destructive (fig. 13).

Figure 13. A chemical reveal on the lower area of bronze-work is demarcated with tape, 2013.

These reveals were problematic in a number of ways. The chemical reveals using paint stripper proved to be uncontrollable and risked damaging original finish layers. The interpenetration of finish layers augmented this risk. Also, the overpaint proved to be tenacious in areas. It was impossible to predict how many layers the paint stripper would remove in any given location. Mechanical reveals with scalpels were found to be only slightly more controllable, and they were extremely time-consuming - impractical to recommend as a treatment option.

Ultimately, the reveals did not assist the team in determining the original decorative scheme, and the recommendation was made that further testing be carried out with specially formulated cleaning gels.
