Article: *The Masterworks* exhibition: A case study in climate control and the role of the conservator in an international exhibition

Author(s): Shelley Reisman Paine

Source: *Objects Specialty Group Postprints, Volume One, 1991*

The *Masterworks* Exhibition - A Case Study in Climate Control and the Role of the Conservator in an International Exhibition.

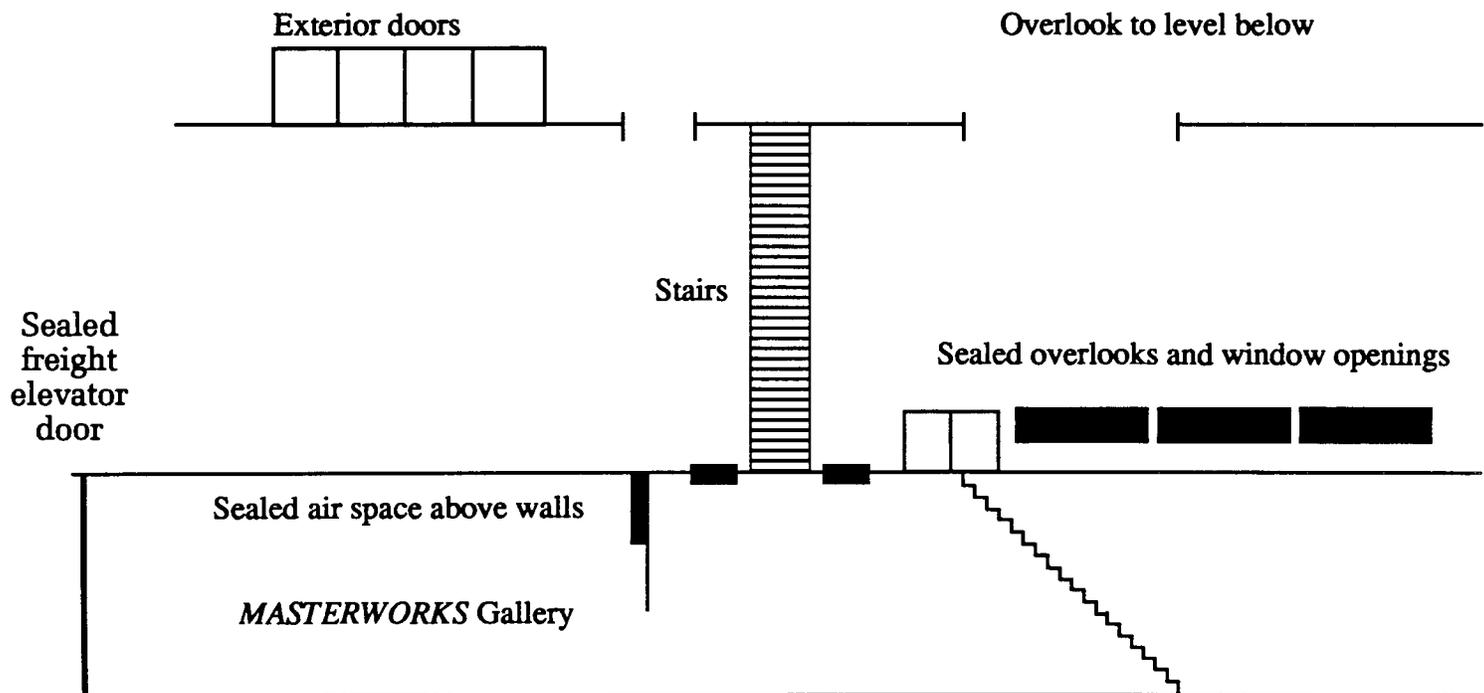
MODIFICATION TO REDUCE INVASION OF OUTSIDE AIR INTO THE *MASTERWORKS* GALLERY

Figure 3 demonstrates how the air infiltration was reduced. The modification are shown here in black.

The openings at the base of the stairwell were closed with plywood sealed in place. This restricted outside air from falling through the openings directly into the gallery level.

The doors to the escalator stairwell were closed, again preventing the easy passage of air.

The freight elevator and loading dock use procedures were changed. The elevator opens both onto the dock and into the Masterworks gallery. The elevator was sealed at the gallery level to prevent the cold, dry air from dropping down from the loading dock into the gallery. Procedures were changed to prevent the dock door from being open when the elevator door was open to prevent outside air infiltration.
